## Smoke and Dye-Water Observation Summary

### Western Run Pilot Project - Baltimore Maryland

Dye Test 100

STREET: CROSS COUNTRY BLVD.	MAP #1: N Not Controlled	MH: 0691486
CITY: BALTIMORE 100 B 7	MAP #2:	MH: 0691518
LOCALE: F Sidewalk	TAPE #: JAM 5	TV'D LGTH: 185.13 ft

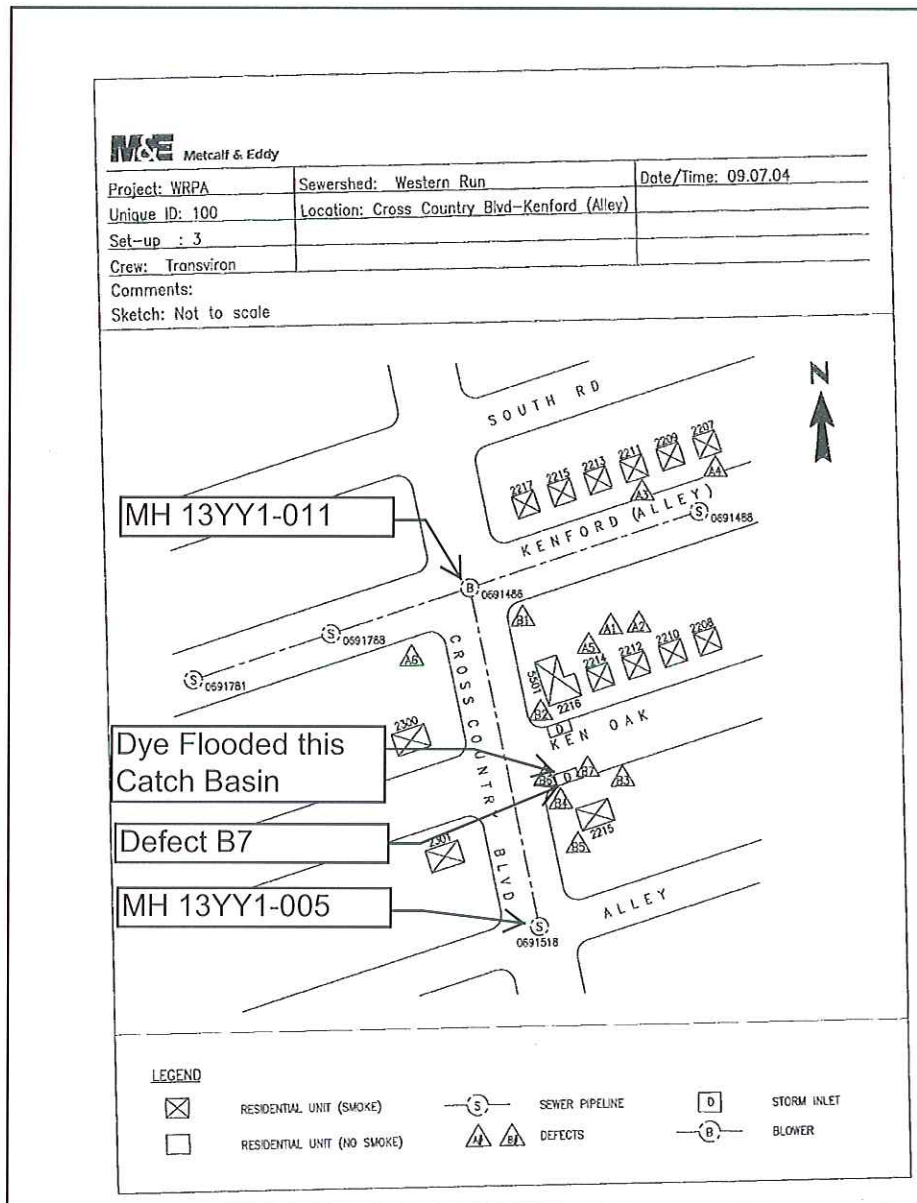
Sketch No: 100

Dye Flooded this  
Catch Basin

Defect B7

B2 WAS NOT DYE FLOODED AT THIS TIME

AS PER BILL FREEDY - WOULD HAVE SAME

RESULTS AS B7

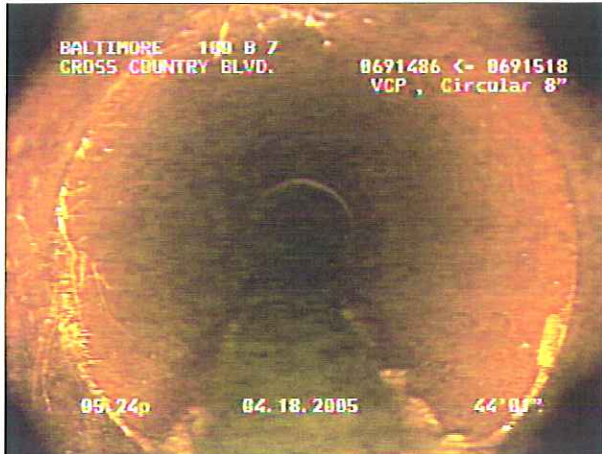
IMAGE: 8a, TAPE #: JAM 5, 00:08:55  
44.07FT, Roots, Fine, Connection, from 08 to 12 o'clock

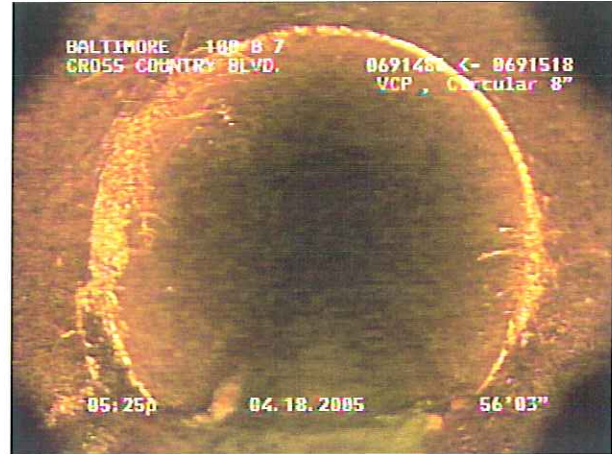
IMAGE: 9a, TAPE #: JAM 5, 00:09:35  
56.24FT, Roots, Fine, Connection, from 09 to 11 o'clock

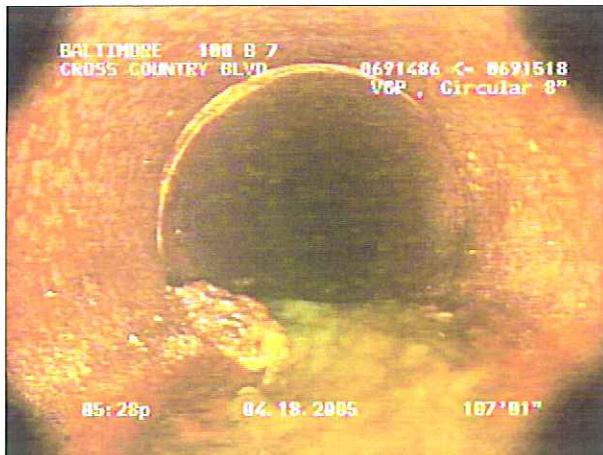
IMAGE: 11a, TAPE #: JAM 5, 00:12:12  
107.05FT, Obstacles, Brick or Masonry, less than 10% of cross sectional area, from 06 to 08 o'clock

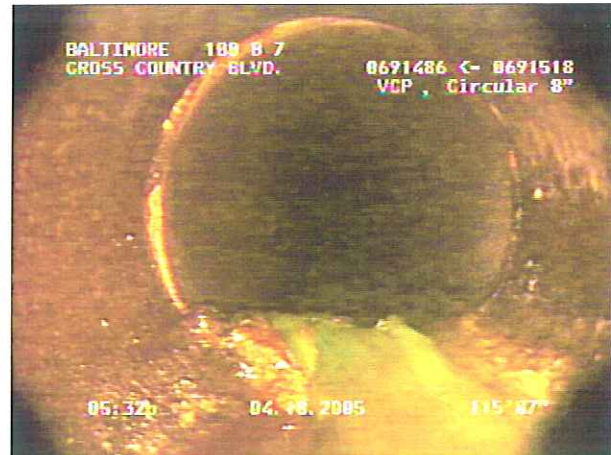
IMAGE: 12a, TAPE #: JAM 5, 00:12:54  
115.6FT, Obstacles, Brick or Masonry, less than 10% of cross sectional area, from 05 to 08 o'clock, start

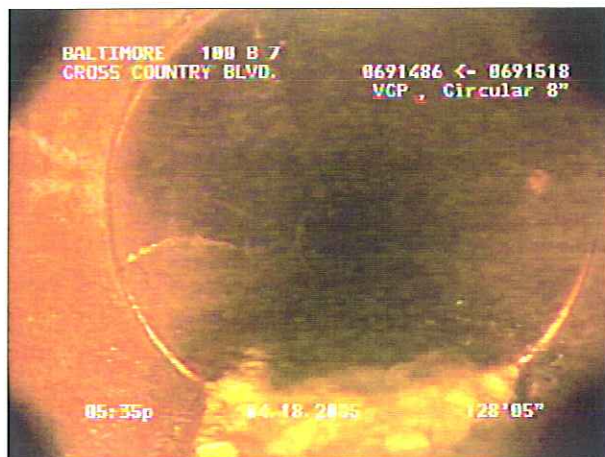
IMAGE: 14a, TAPE #: JAM 5, 00:14:15  
128.38FT, Crack, Longitudinal, Non continuous (less than 3 feet long), at 09 o'clock & 11 o'clock

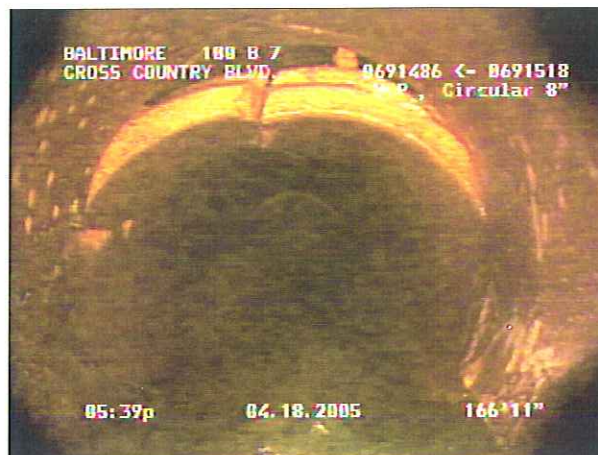
IMAGE: 15a, TAPE #: JAM 5, 00:17:16  
166.92FT, Pipe Failure, Broken, Break extends to more than 3 clock positions, from 08 to 04 o'clock

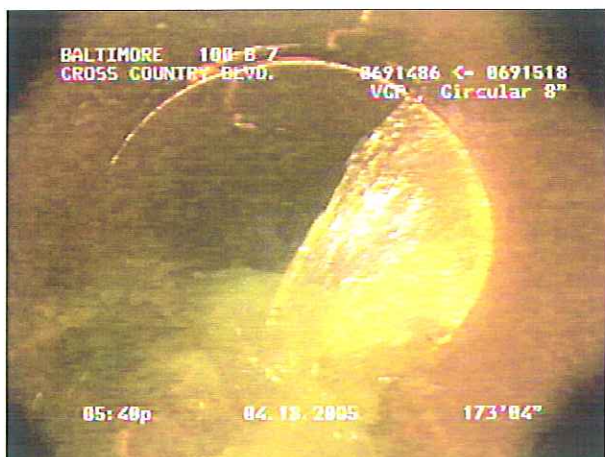
IMAGE: 16a, TAPE #: JAM 5, 00:17:53  
173.36FT, Infiltration, Gusher, from 01 to 04 o'clock

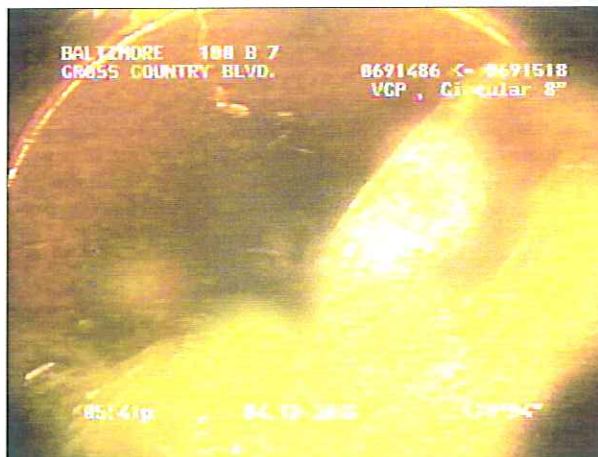
IMAGE: 17a, TAPE #: JAM 5, 00:17:56  
173.36FT, Fracture, Longitudinal, Non continuous (less than 3 feet long), at 11 o'clock

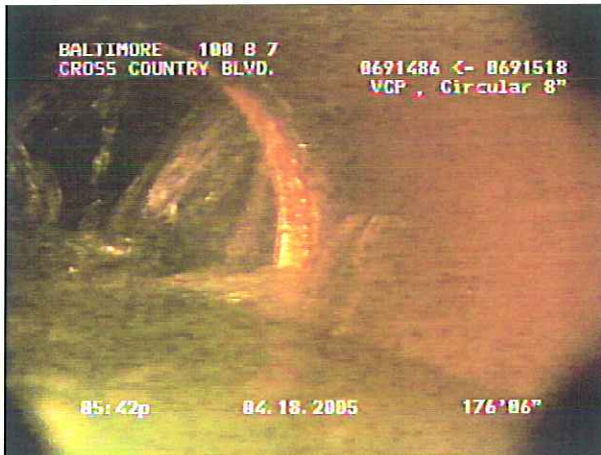
IMAGE: 18a, TAPE #: JAM 5, 00:19:00  
176.47FT, Infiltration, Runner, at 03 o'clock

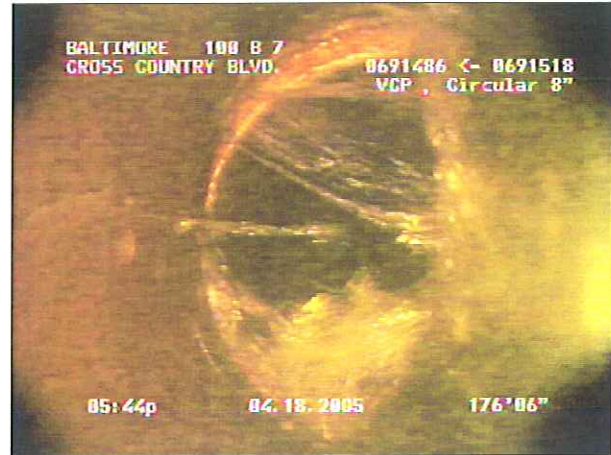
IMAGE: 19a, TAPE #: JAM 5, 00:19:00  
176.47FT, Infiltration, Gusher, from 12 to 12 o'clock

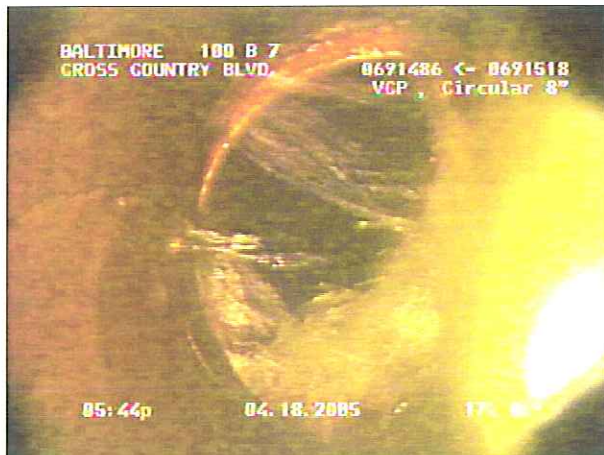
IMAGE: 20a, TAPE #: JAM 5, 00:19:00  
176.47FT, Infiltration, Runner, at 12 o'clock

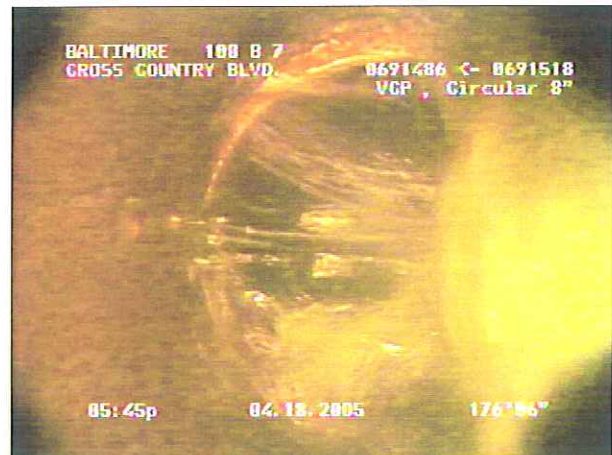
IMAGE: 21a, TAPE #: JAM 5, 00:19:00  
176.47FT, Crack, Longitudinal, Non continuous (less than 3 feet long), at 12 o'clock & 3 o'clock

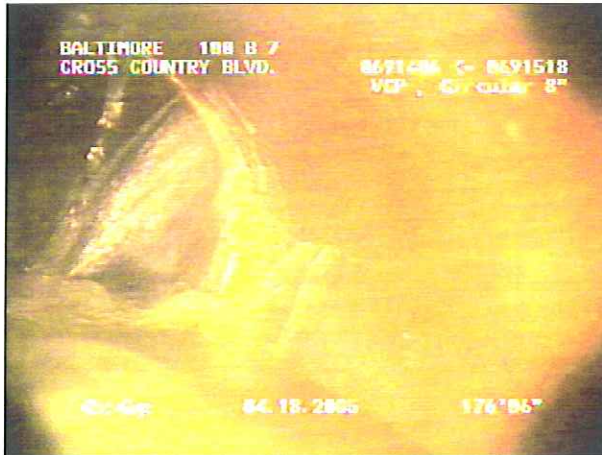
IMAGE: 21b, TAPE #: JAM 5, 00:19:00  
176.47FT, Crack, Longitudinal, Non continuous (less than 3 feet long), at 12 o'clock & 3 o'clock

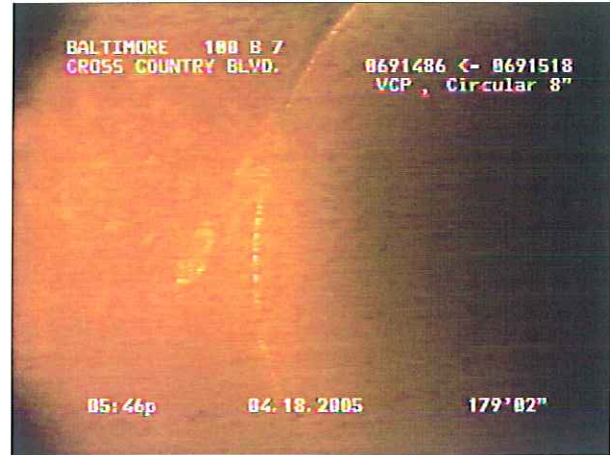
IMAGE: 22a, TAPE #: JAM 5, 00:19:55  
179.19FT, Infiltration, Runner, at 10 o'clock

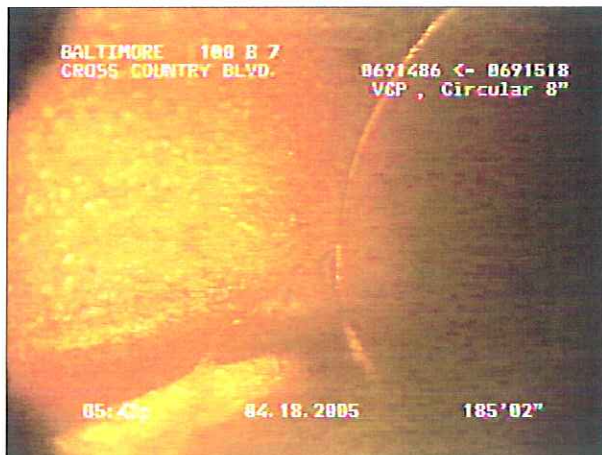
IMAGE: 23a, TAPE #: JAM 5, 00:20:50  
185.13FT, Crack, Longitudinal, Non continuous (less than 3 feet long), at 08 o'clock

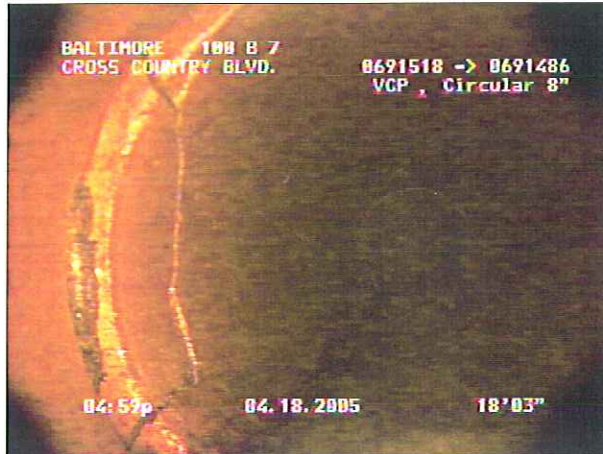
IMAGE: 2a, TAPE #: JAM 5, 00:01:29  
18.21FT, Fracture, Circumferential, Less than 50% of Circumference, from 08 to 10 o'clock

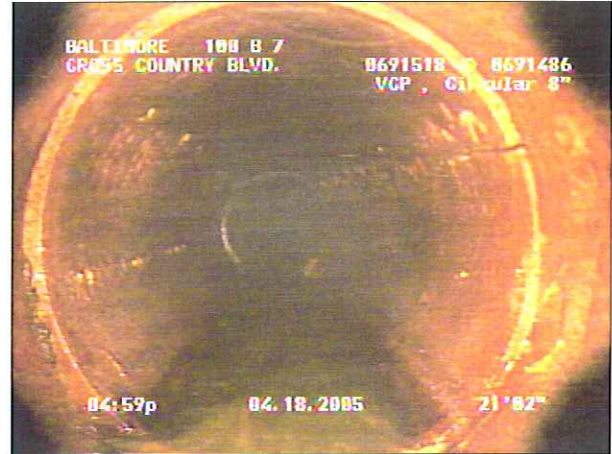
IMAGE: 3a, TAPE #: JAM 5, 00:01:47  
21.13FT, Circumferential, Less than 50% of Circumference, from 02 to 04 o'clock

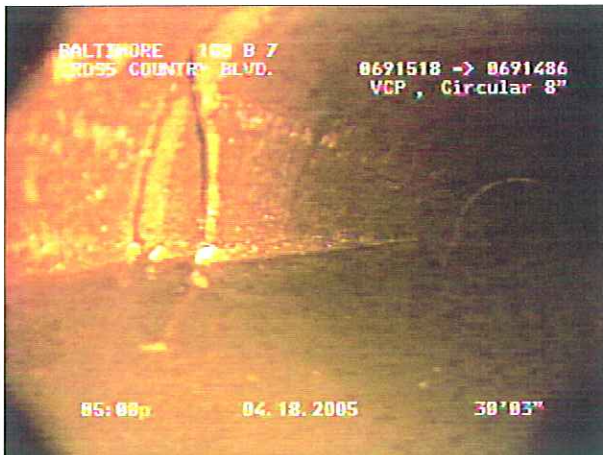
IMAGE: 4a, TAPE #: JAM 5, 00:02:23  
30.28FT, Fracture, Circumferential, Less than 50% of Circumference, from 08 to 10 o'clock

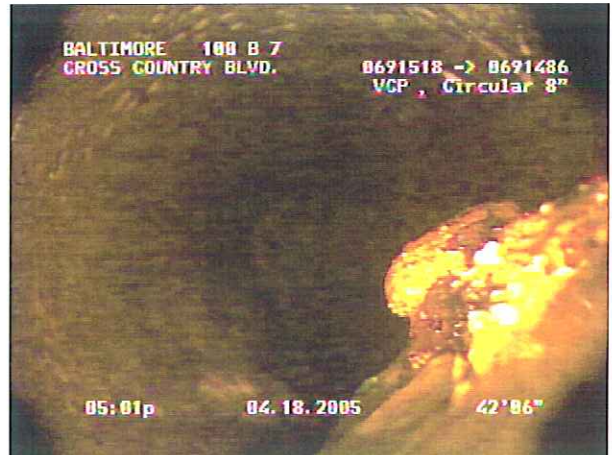
IMAGE: 5a, TAPE #: JAM 5, 00:03:14  
42.46FT, Obstacles, Brick or Masonry, greater than 10% less than 30% of cross sectional area, from 05 to 07 o'clock

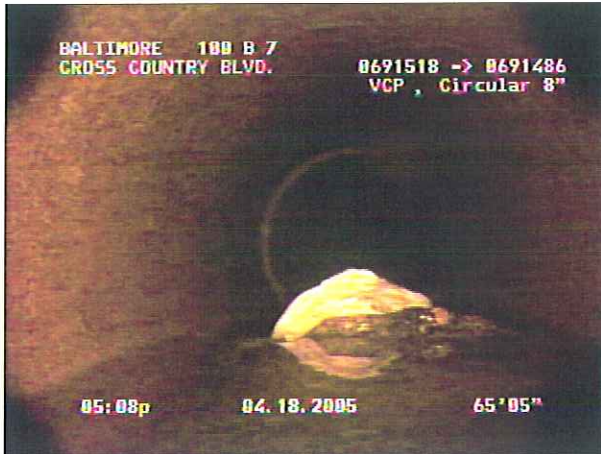
IMAGE: 6a, TAPE #: JAM 5, 00:06:44  
65.4FT, Miscellaneous, Survey Abandoned, CONCRETE  
CHUNK PUSHED DOWN FROM 42"

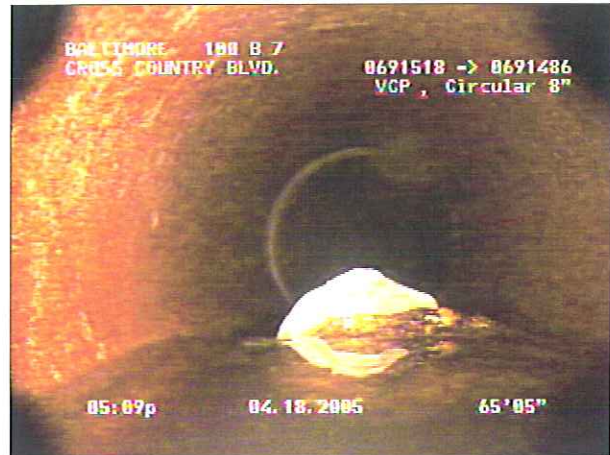
IMAGE: 6b, TAPE #: JAM 5, 00:06:44  
65.4FT, Miscellaneous, Survey Abandoned, CONCRETE  
CHUNK PUSHED DOWN FROM 42"
